DEPARTMENT OF TRANSPORTATION

Contract #: 04-0120F4Cty: SF/ALA Rte: 80 PM: 13.2/13.9File #: 69.28**WELDING INSPECTION REPORT****Resident Engineer:** Siegenthaler, Peter**Address:** 333 Burma Road**City:** Oakland, CA 94607**Report No:** WIR-017444**Date Inspected:** 04-Oct-2010**Project Name:** SAS Superstructure**OSM Arrival Time:** 700**Prime Contractor:** American Bridge/Fluor Enterprises, a JV**OSM Departure Time:** 1900**Contractor:** Zhenhua Port Machinery Company, Ltd (ZPMC), Changxing Island **Location:** Shanghai, China**CWI Name:** Qiu Wen**CWI Present:** Yes No**Inspected CWI report:** Yes No N/A**Rod Oven in Use:** Yes No N/A**Electrode to specification:** Yes No N/A**Weld Procedures Followed:** Yes No N/A**Qualified Welders:** Yes No N/A**Verified Joint Fit-up:** Yes No N/A**Approved Drawings:** Yes No N/A**Approved WPS:** Yes No N/A**Delayed / Cancelled:** Yes No N/A**Bridge No:** 34-0006**Component:** Tower & OBG Components**Summary of Items Observed:**

ORTHOTROPIC BOX GIRDER (OBG) AT BAY#10

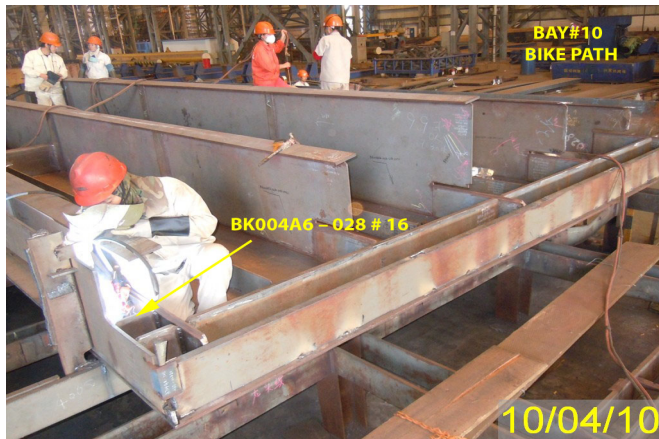
Weld joint # 16 located on Bike Path BK004A6 – 028. Welder is identified as 053869. ZPMC Quality Control (QC) Inspector is identified as Li Jun. The welding variables recorded by QC appeared to comply with the WPS – B – T – 2133. (See attached photo)

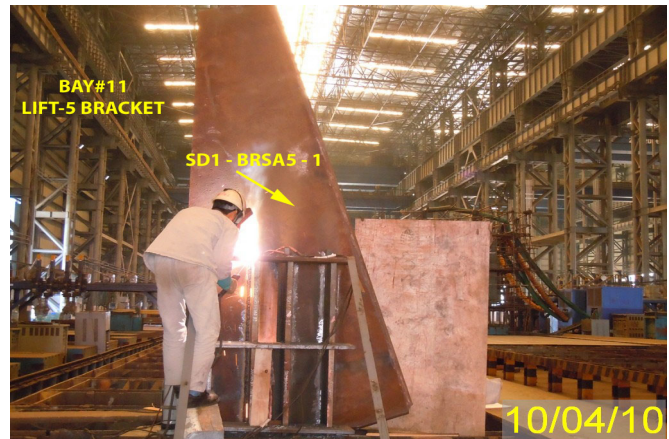
Weld joint # 8B located on Lift-5 Bracket SD1 – BRSA5 – 1. Welder is identified as 041271. ZPMC Quality Control (QC) Inspector is identified as Yu Dong Ping. The welding variables recorded by QC appeared to comply with the WPS – B – T – 3213 – Tc – U4b. (See attached photo)
